## Causes, Trends and Long Term Consequences of Leg Injury

Patricia Dischinger, PhD; Andrew Burgess, MD; Kathy Read, MSW University of Maryland CIREN Team

CIREN 99-283-133

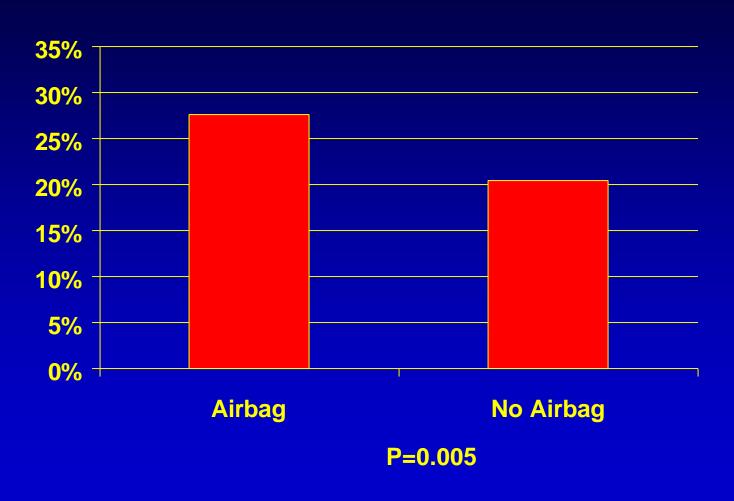
## **Lower Extremity Fractures by Airbag**Frontal Collision Only (n=4,887)

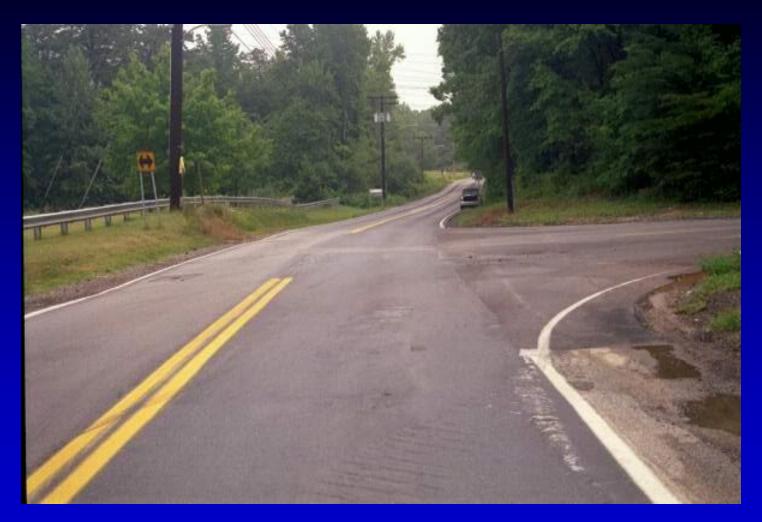
Vehicle 1 - Travel Path (viewing NE)

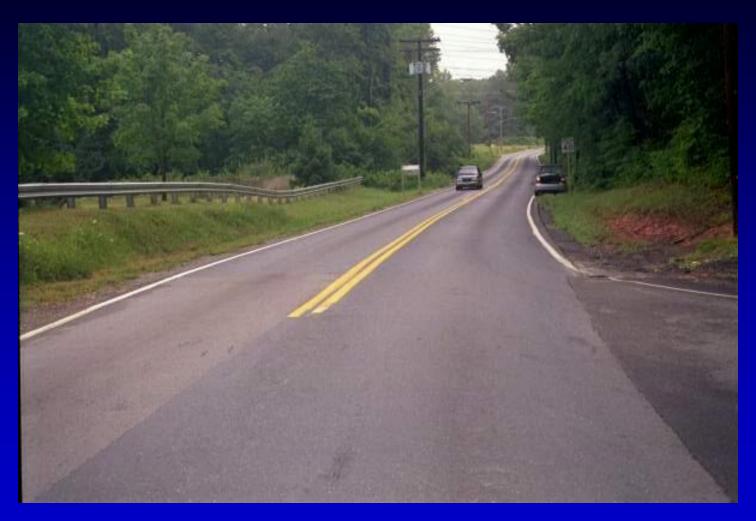
Vehicle 1 - Travel Path and POI 1

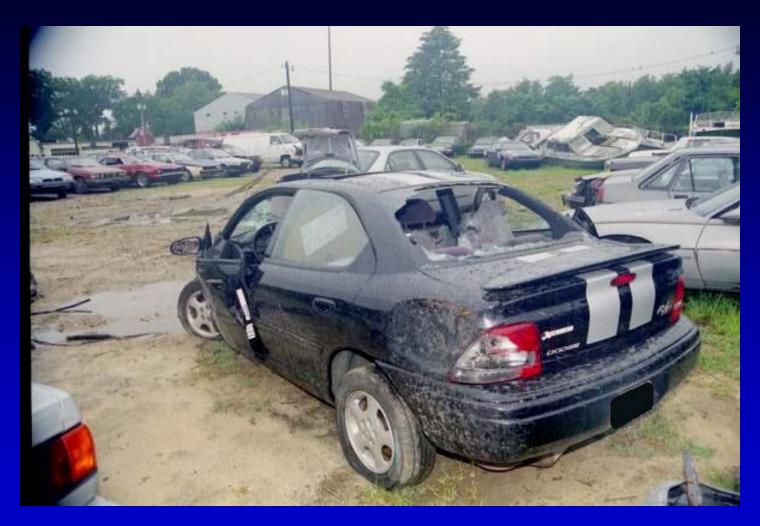
Vehicle 1 – 1998 Dodge Neon

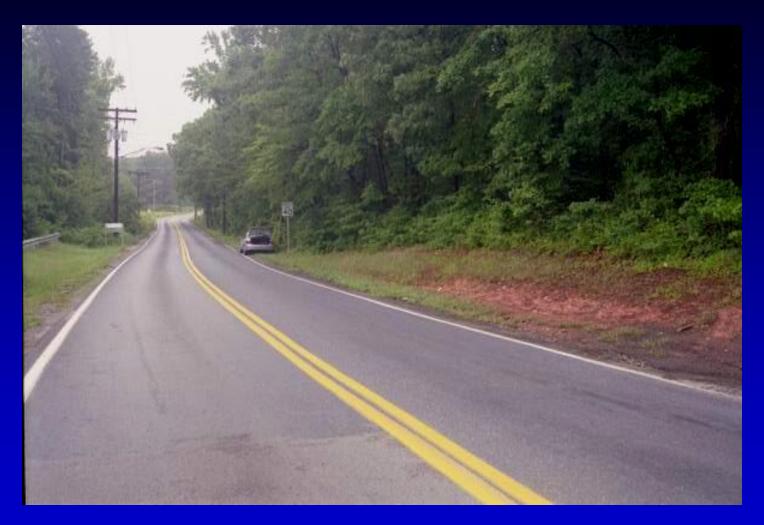
Vehicle 1 – Travel path from POI 1

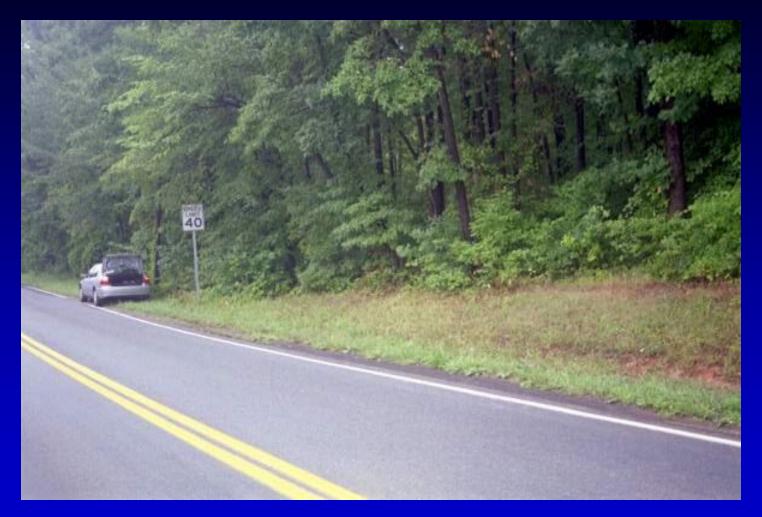
Vehicle 1 – Travel path from POI 1 (viewing east)

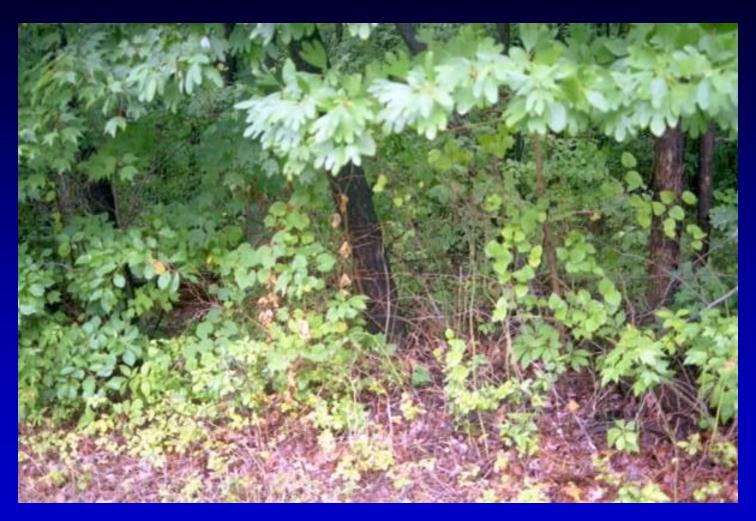
POI 2 – 13" diameter tree

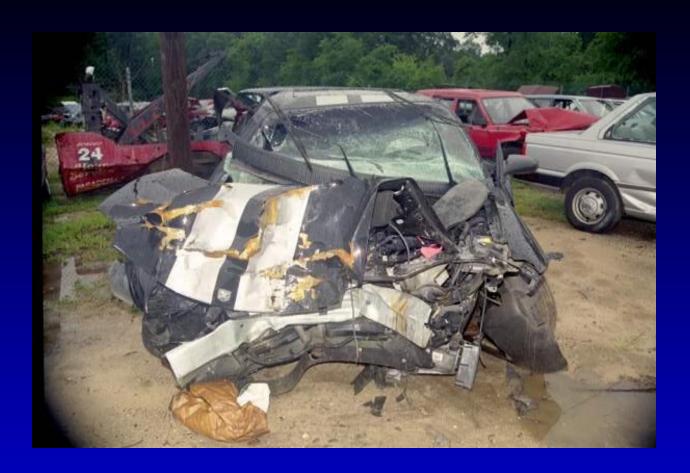
Delta V 45mph

PDOF 0 deg.

CDC 12FYEN3

Max Crush 22 inches @ C3

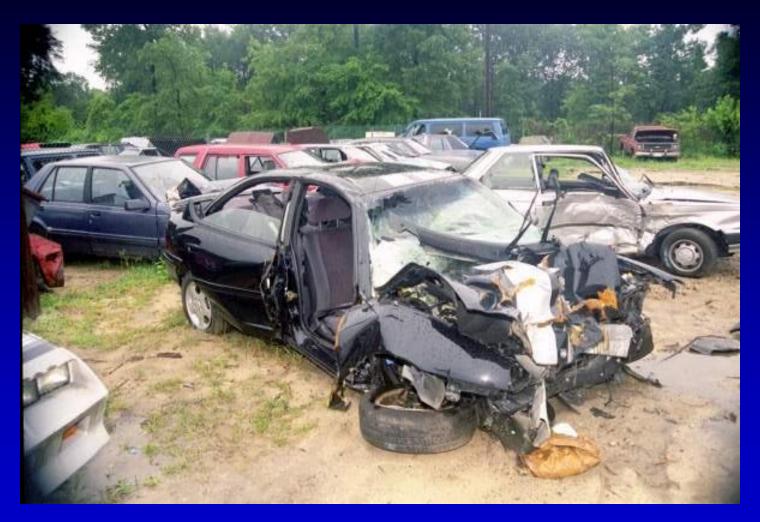
Vehicle 1 - Exterior

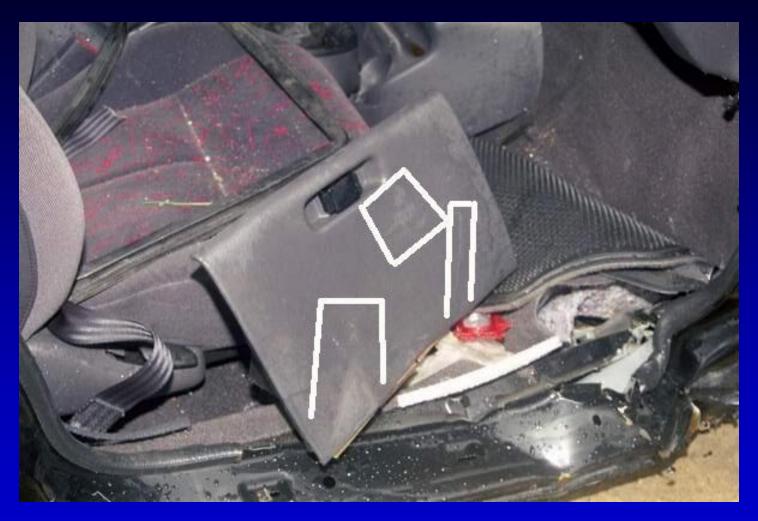
Vehicle 1 – Glove compartment/door contact (R/F occupant)

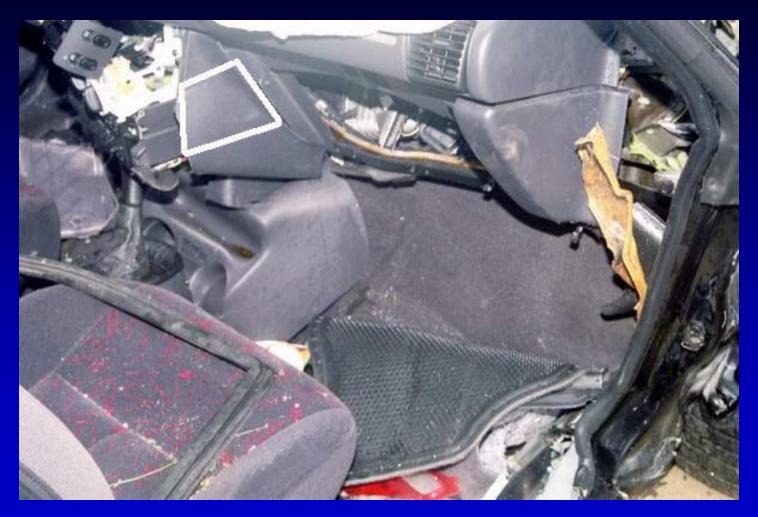
Vehicle 1 – Center inst. panel contact (R/F occupant)

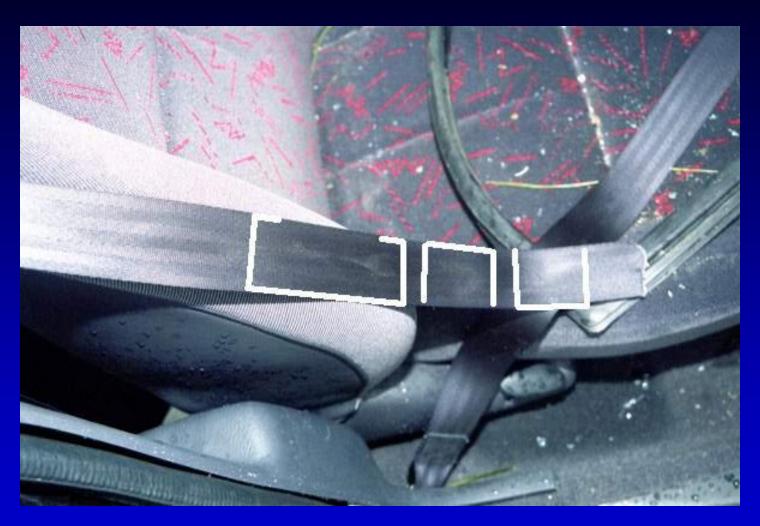
Vehicle 1 – Right restraint load marks

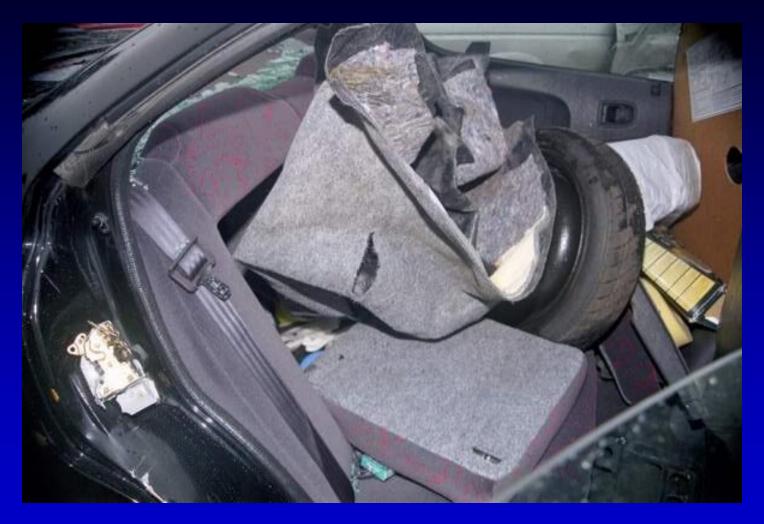
Vehicle 1 – Spare tire and right back seat

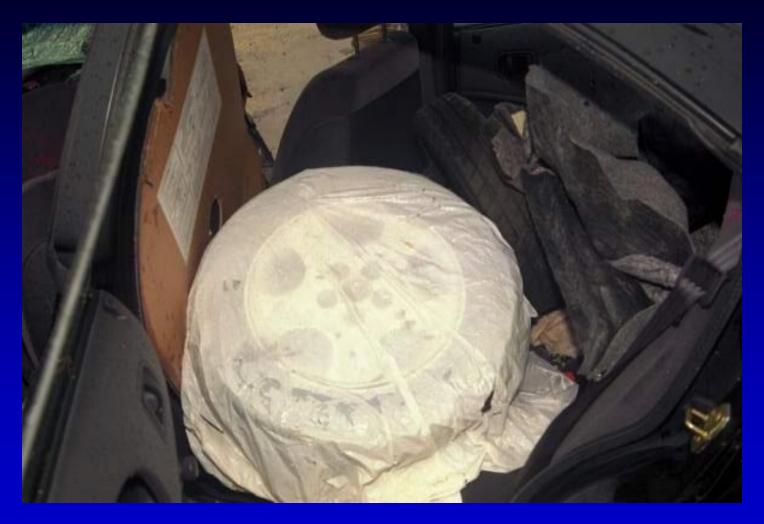
Vehicle 1 – Extra tire and left back seat

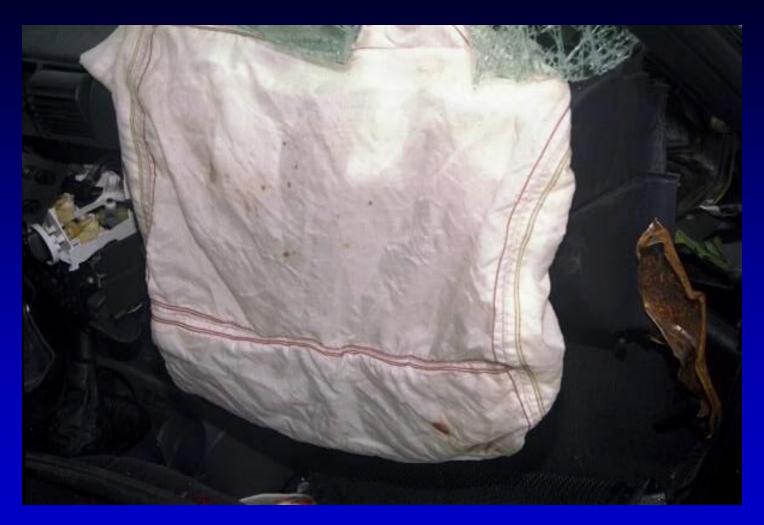
Vehicle 1 – Right front air bag

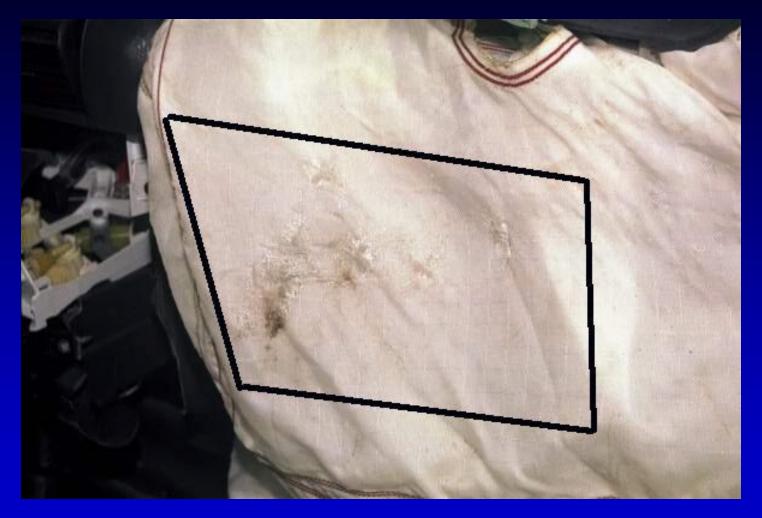
Vehicle 1 – Right front air bag (Tire damage)
